Alaska FACE

FATALITY ASSESSMENT & CONTROL EVALUATION

Lineman killed after contacting charged switch

FACE 00-AK-011

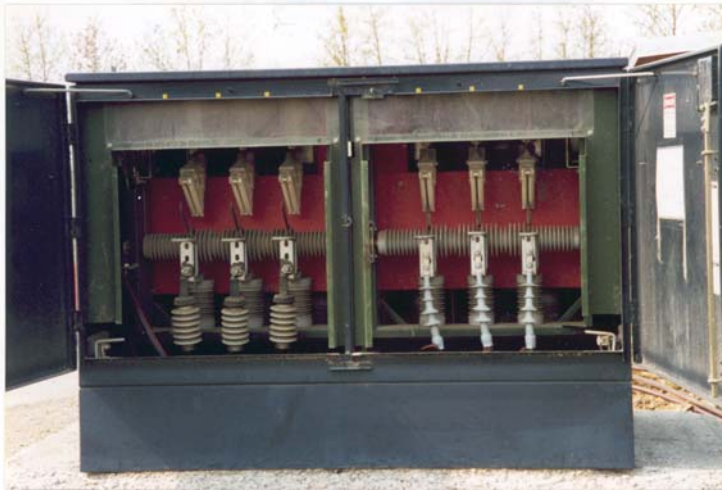
The switch cabinet involved in this incident was a pad-mounted cabinet with a metal exterior. The cabinet was approximately 6½ feet wide, 4 feet deep and approximately 3½ feet tall. The cabinet contained six switches aligned side by side along the 6½-foot length of the cabinet. On the opposite side of the cabinet were six fuses aligned in the same arrangement as the switches. On each side of the 6½-foot length of the cabinet were two access doors (four doors in total). Three switches or fuses were behind each door. (Figure 1)

All four doors to the cabinet were opened to view the area inside the vault. In addition, the insulated safety barrier was removed on the energized portion of the cabinet in front of the switches to provide better visibility and access to the cable. The victim using a hot stick had already looped several feet of cable within the vault, and the apprentice was observing his

Figure 1. View of open switch cabinet

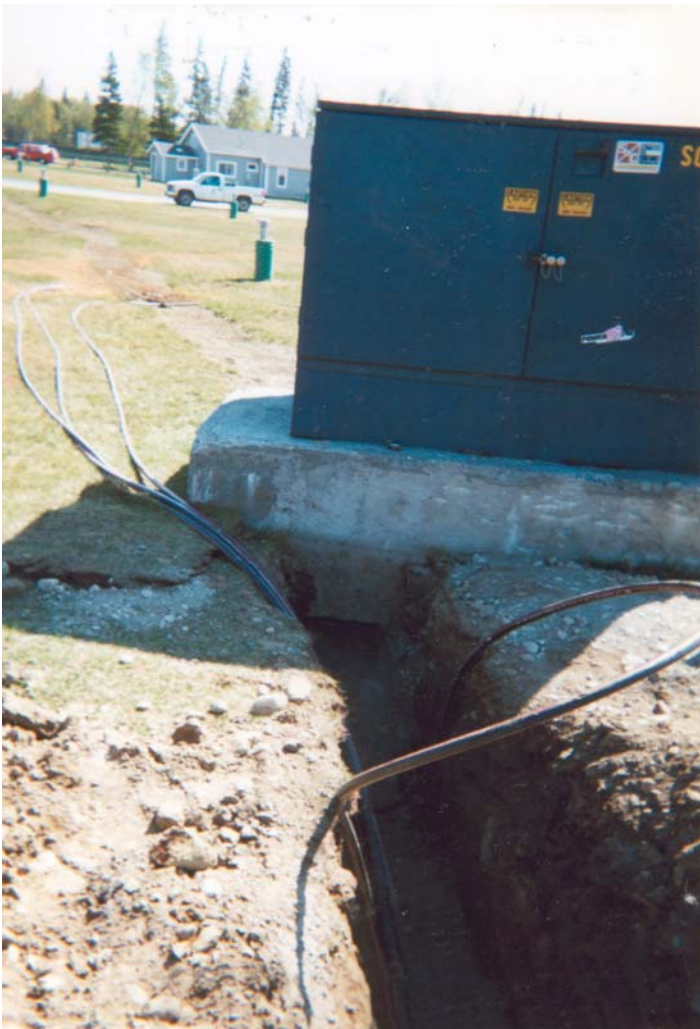
The cabinet was open at the bottom and rested on a pre-formed concrete foundation or vault. The vault was approximately 3 feet deep--1 foot above and 2 feet below ground. Normally, several feet of cable were looped around the interior perimeter of the vault. This is a normal industry practice.

Figure 2. View of trench and cables leading under foundation
